MX880 series

Service Manual

(MX882 / MX883 / MX884 / MX885 / MX886 / MX888)

QY8-13DF-000

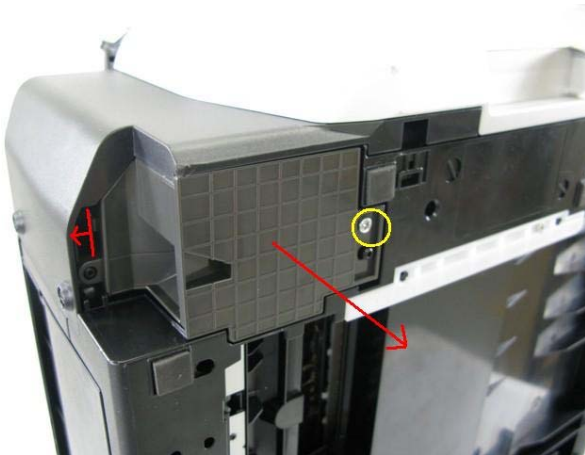
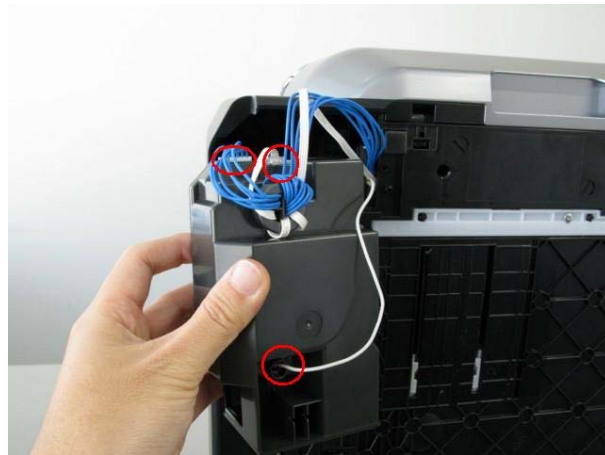
- 1) Remove the cassette and the rear guide unit. (no screws)
- 2) Remove the AC adapter. (1 screw)
<Pull out the AC adapter from the bottom of the bottom case.>
<The core fits to the AC adapter rib.>
See "[3-6. Special Notes on Servicing, \(7\) Power supply unit and modular board replacement.](#)"

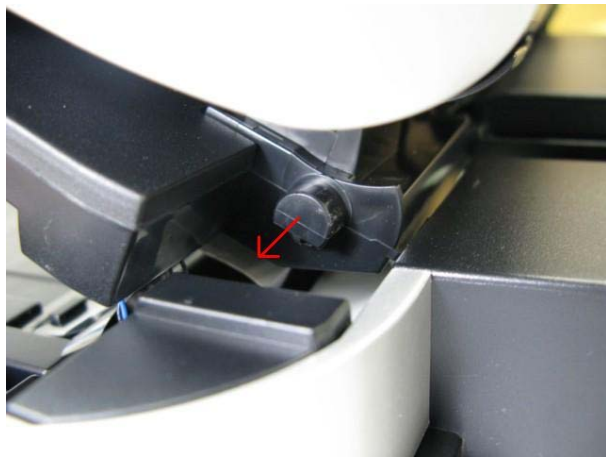
- 3) Remove the side cover R. (2 screws)
<The scanner unit hinges are fitted in the right and left side covers.>

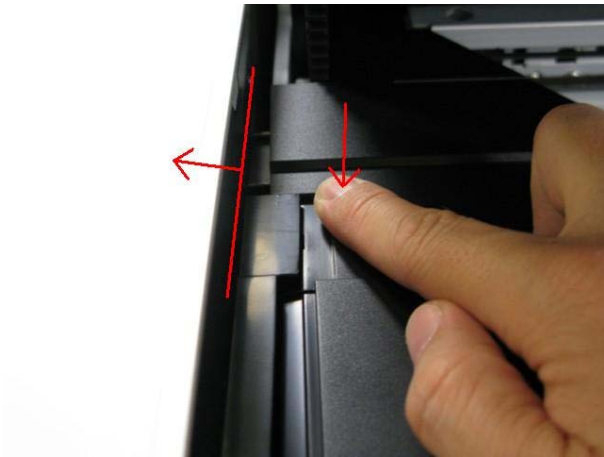
5) Remove the side cover L, disengage the scanner support, then separate the scanner from the printer. (4 screws)

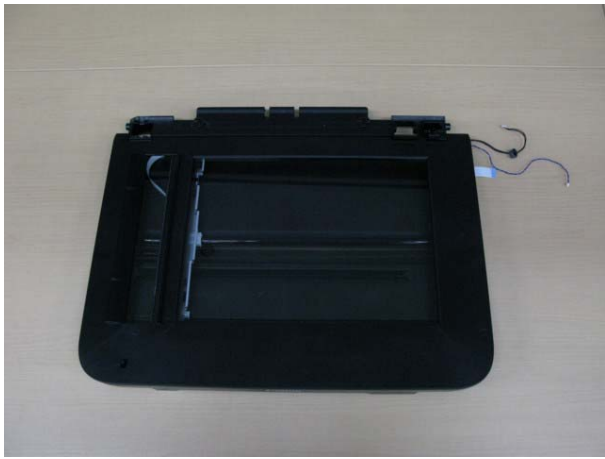
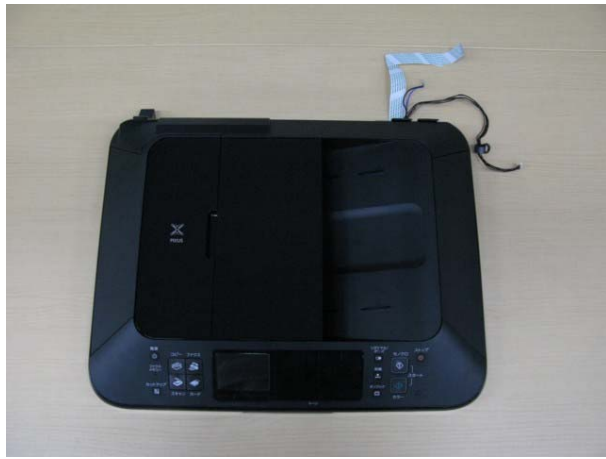
6) Separate the scanner from the document feeder. (no screws)

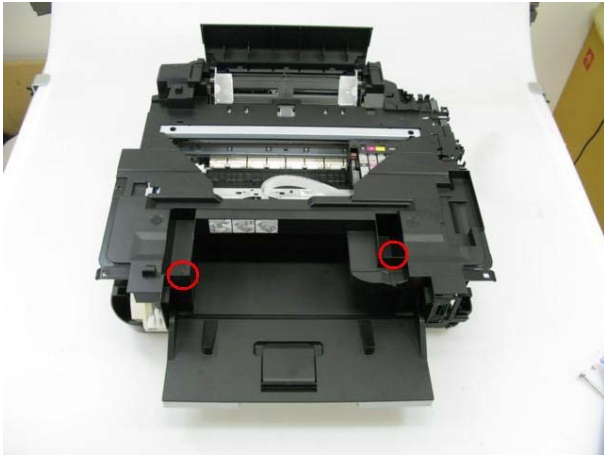
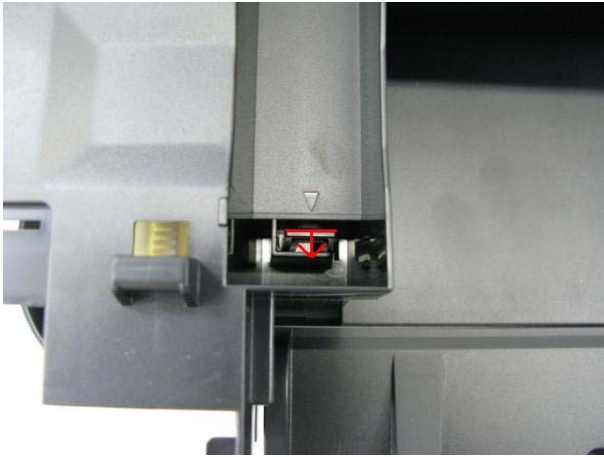
8) Remove the main case. (no screws)

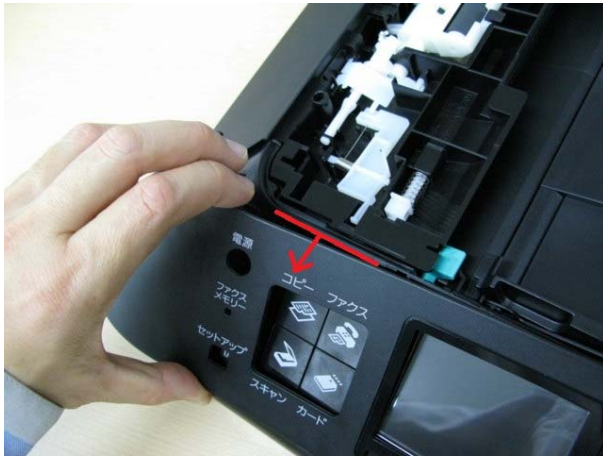
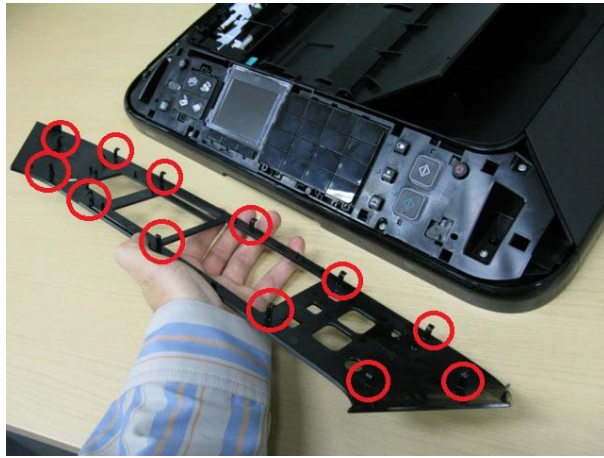
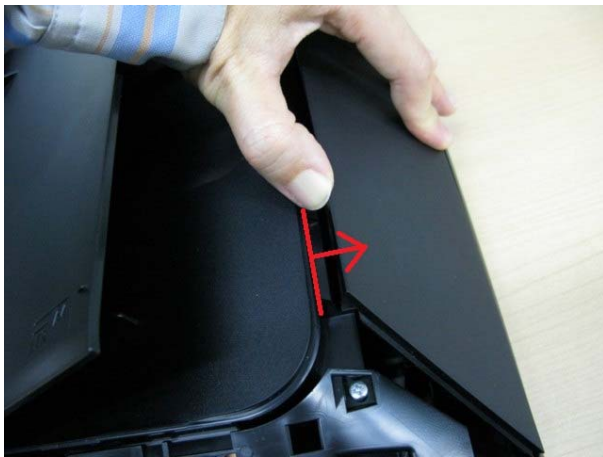
1) Remove the panel cover, right cover, and rear cover. (no screws)

<Be cautious not to damage the tabs and hooks.>

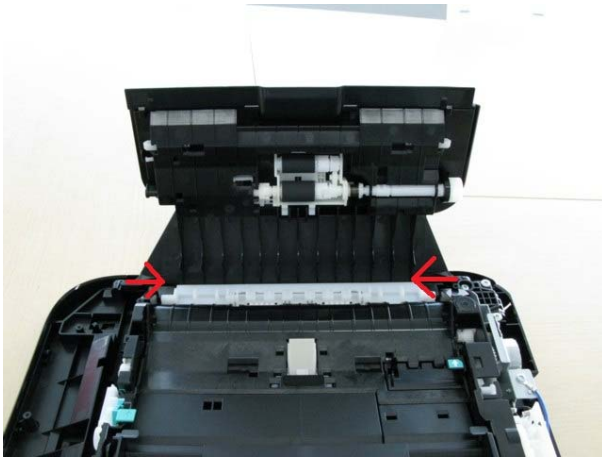
2) Remove the document feed cover.

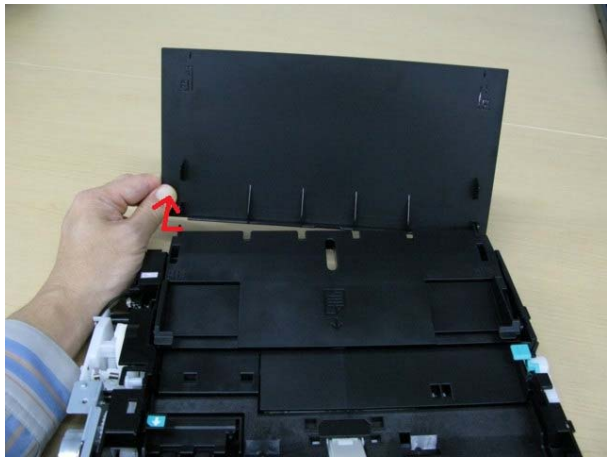
3) Remove the operation panel, document feed tray, eject tray, and document feed unit. (16 screws)
<The core fits to the document feed base rib.>

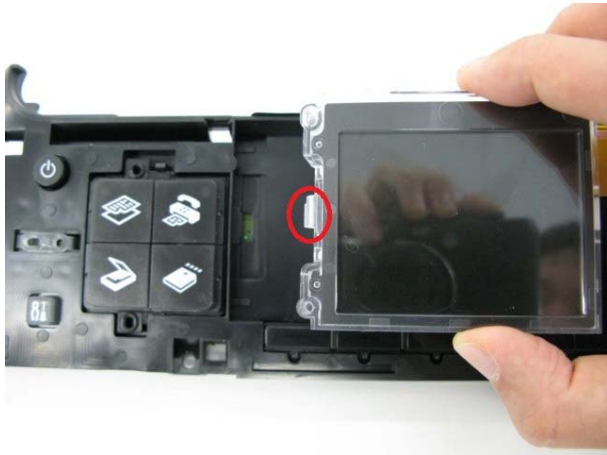
4) Remove the LCD ass'y. (no screws)

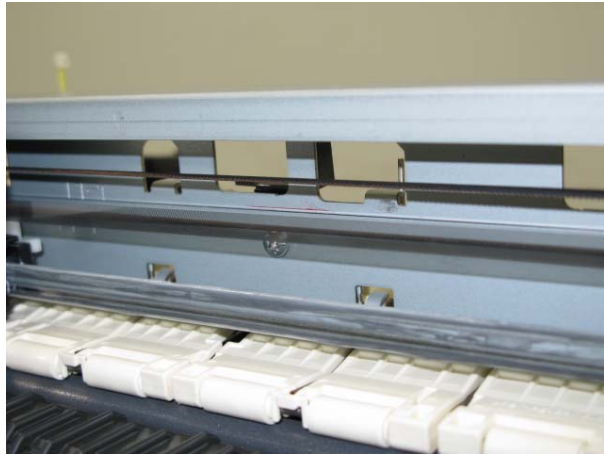
- 1) On the main chassis, mark the positions of the screws that fix the carriage rail to the main chassis (3 points for each screw: the left, right, and center).

Before removing the screws from the carriage rail, put a mark on the main chassis to indicate the carriage rail position.

After replacing the carriage, return the carriage rail to the original position while aligning the rail to the mark on the chassis.

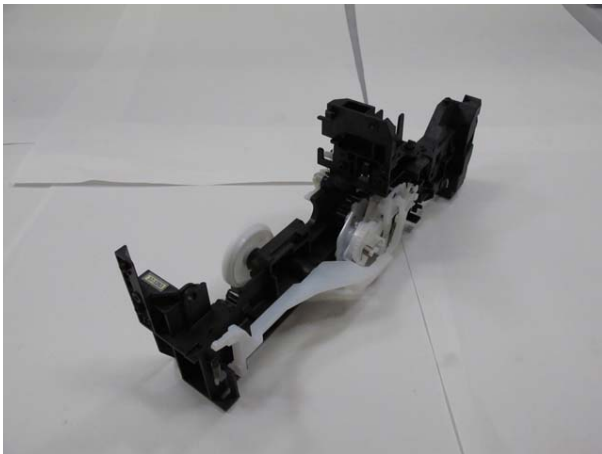
4) Separate the main chassis from the switch system unit and the purge drive system unit.

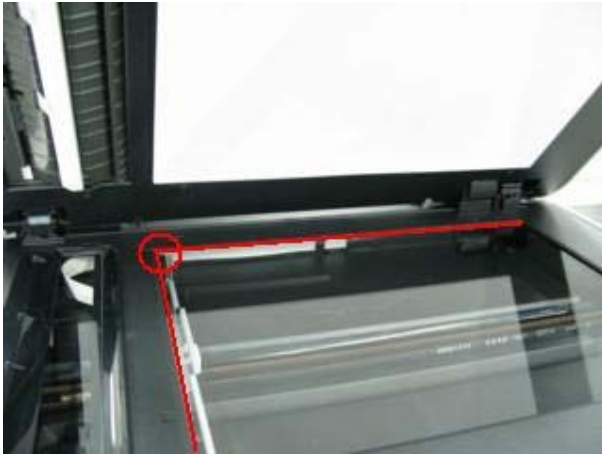
(4) Document pressure sheet (sponge sheet) replacement

- 1) Peel off the cover sheet from the double-sided adhesive tape on the back of the document pressure sheet. With the long-side down, position the upper-left corner of the document pressure sheet at the scanning reference point on the platen glass (back left where the red lines cross in the photo above).
- 2) Slowly close the document pressure plate, while maintaining the hinge position. The document pressure sheet will attach to the plate frame.
- 3) Open the plate to confirm the following:
 - No extension of the sponge edges over the mold part of the upper scanner cover.
 - No gap between the platen glass reference edges and the corresponding sponge edges.
 - No shades or streaks in monochrome test printing without a document on the platen glass.

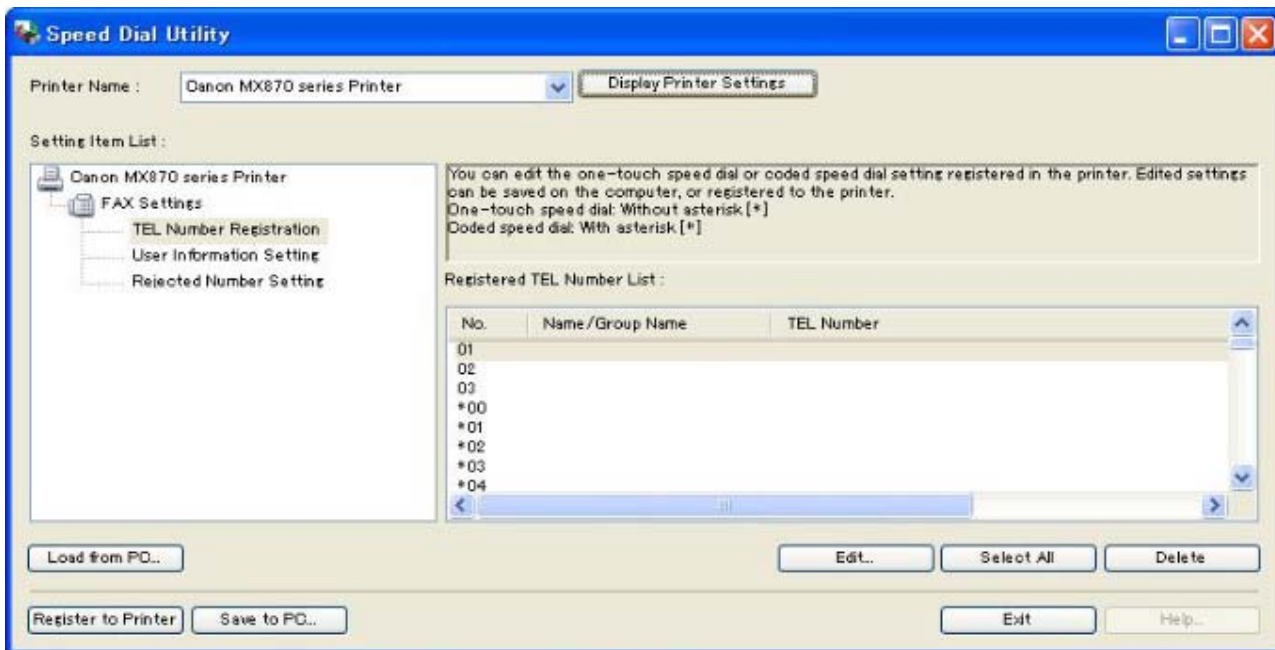
Speed Dial Utility allows users to back up or edit the registered user data (coded speed dials, group dials, phone books, etc.) on a computer. Since those user data is considered as private information and requires a careful handling, we ask users to use this utility.

The dialog box below is for the MX870 as an example.

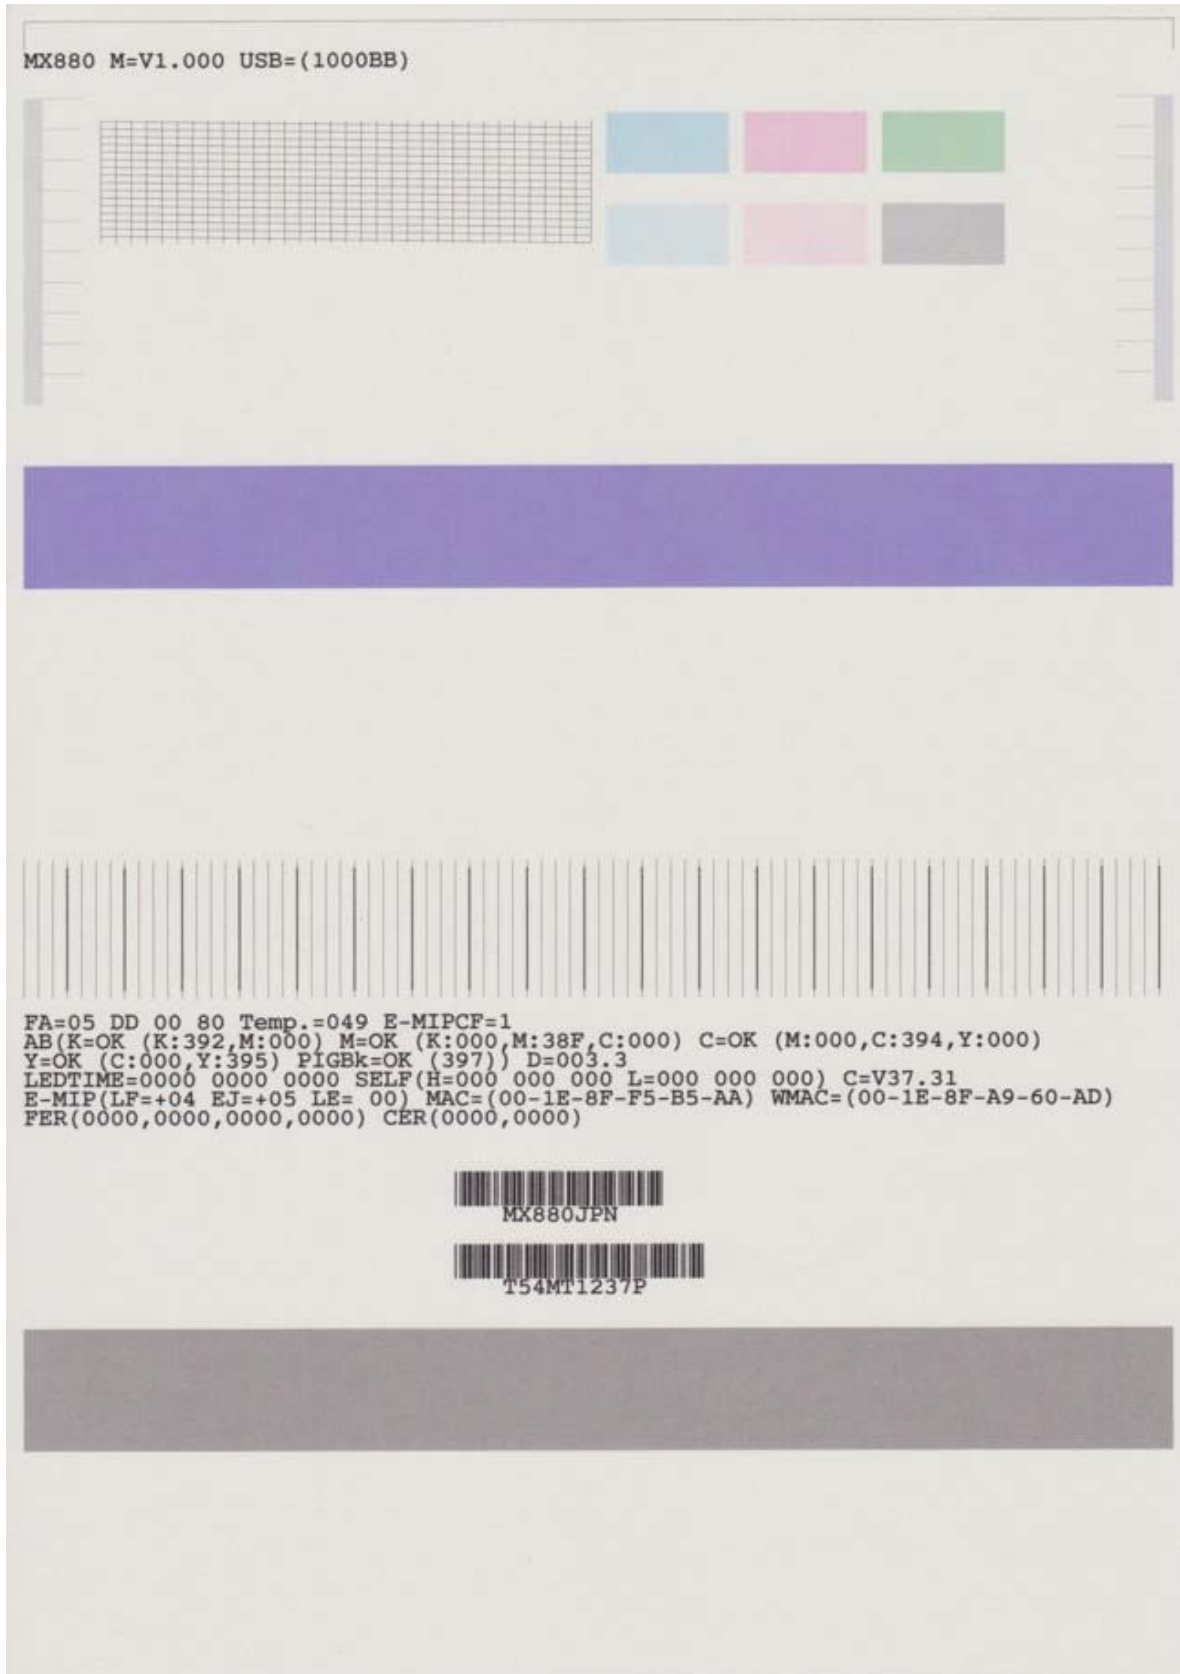
4-2. Integrated Inspection Pattern Print

< Print sample >
